High Seas, High Water

In Gale Conditions off the Treacherous

Grand Banks, Dirona Takes on Water

JAMES & JENNIFER HAMILTON

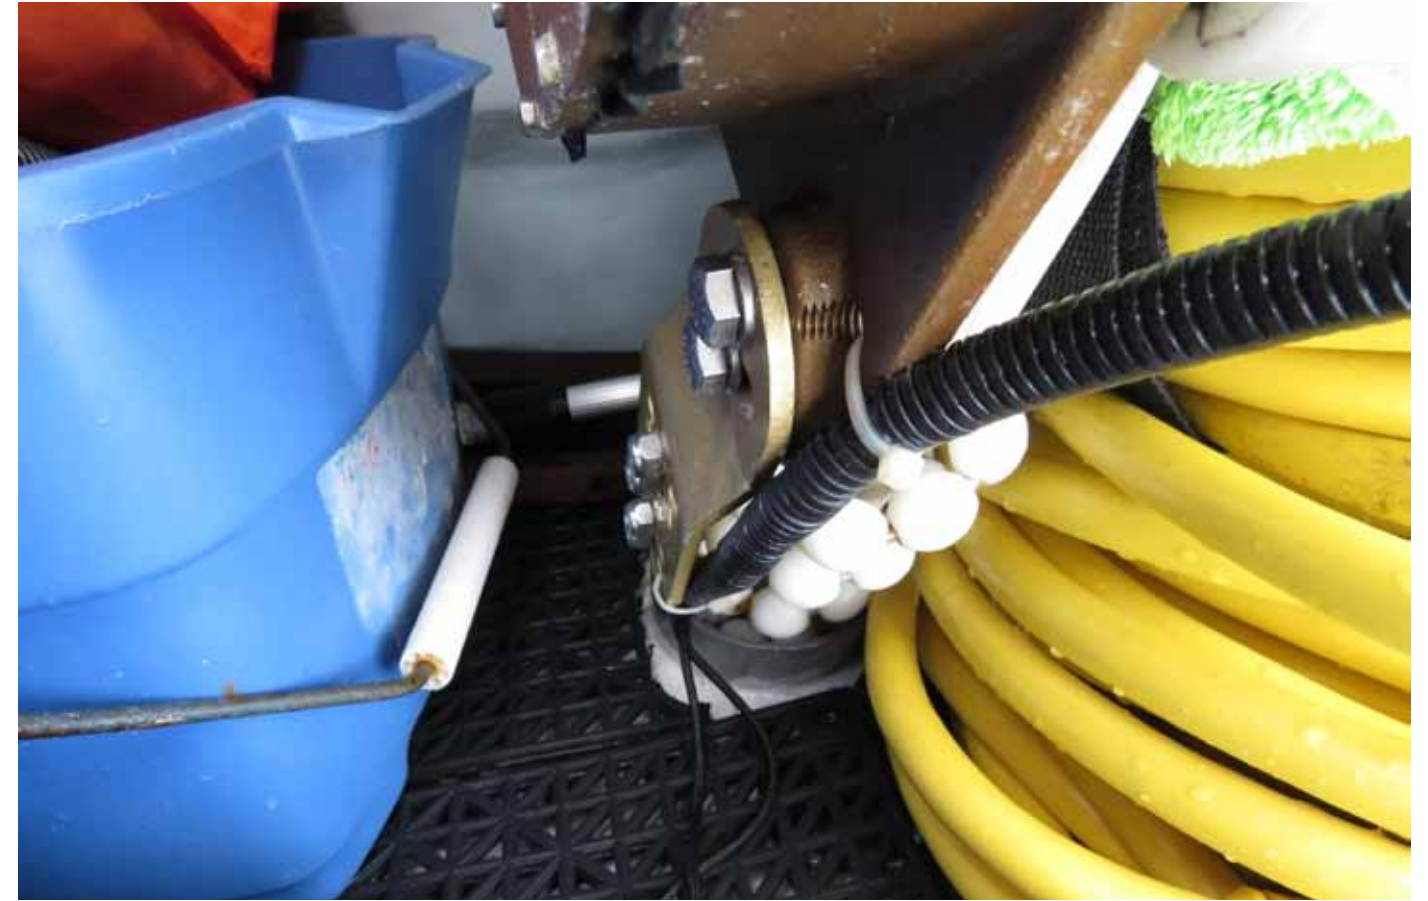
Opposite: This marine version of a tourniquet on the power cord entry substantially reduced the rate of water inflow. **Above:** The cockpit locker frequently contained several inches of water, and seawater was pouring into the lazarette through the shorepower cord standpipe.

Working in the lazarette, I jammed foam insulation into the power-cord entrance hole, but the pressure from the several inches of water above rendered my foam stoppers useless. I then used a screw driver to force rags into the hole to fill small gaps, and this began to show some promise. Finally, I wrapped a towel around the entire assembly and compressed it tightly, using rope and a couple of heavy-duty wire ties. This marine version of a tourniquet substantially reduced the flow. Nearly four hours had passed since the alarm sounded, and having to operate the emergency bilge pump was distracting and nerve-wracking. The rate of water ingress was now only what could soak through the towels—fairly minimal and required running the emergency bilge pump only every 15 minutes or so. But something must also be wrong with the main bilge pump, because it should easily be able to handle that level of flow.

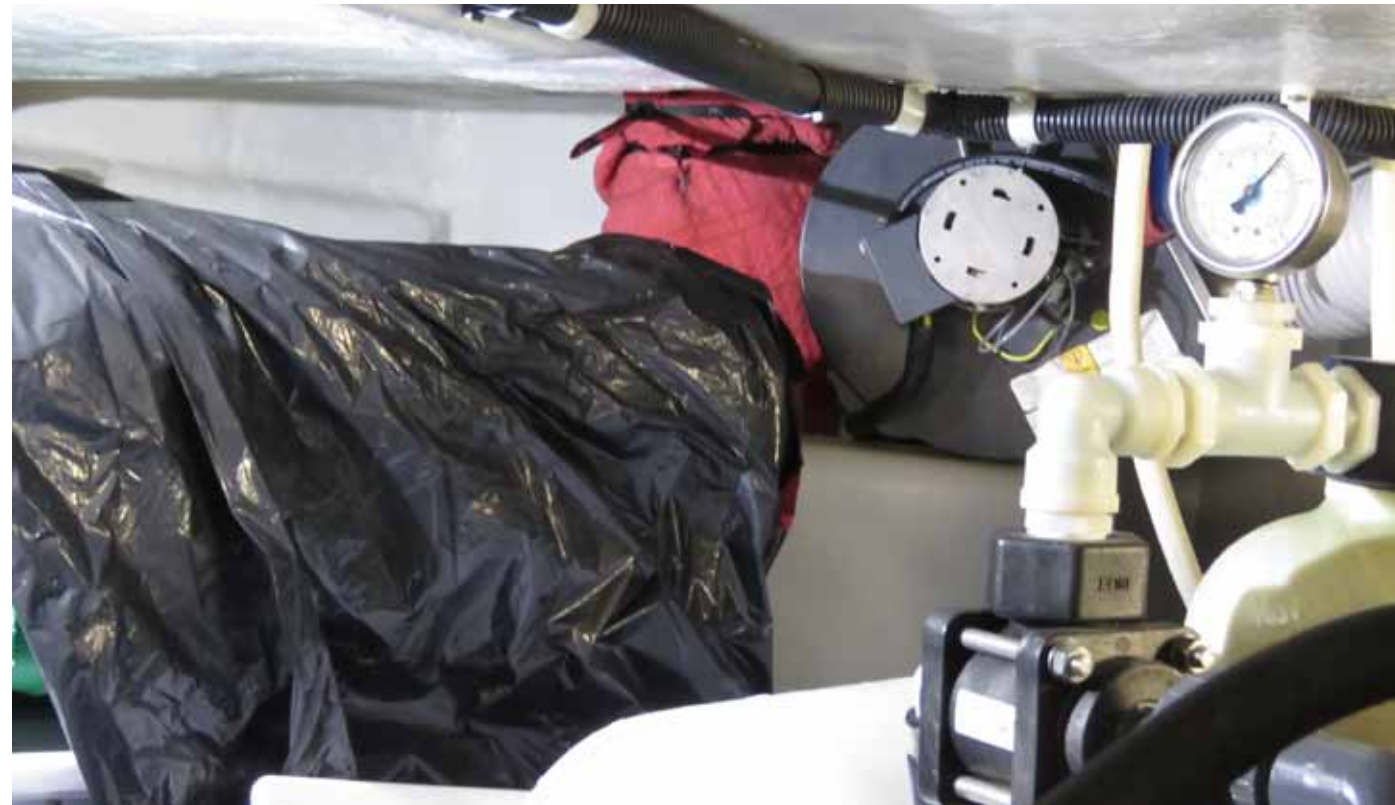
The cockpit lights were on, I was wearing a headlamp, and I had a flashlight, giving me ample light, but night made the entire situation more difficult. Every tenth wave sprayed over the transom, and I was soaked in cold sea water. Inside the locker, I could see water flowing down the standpipe that feeds the shorepower cord below. What prevents water ingress on this path

is a one-inch-high collar around the hole. Until the water gets above the collar, nothing goes into the lazarette. The problem was the water line in the locker was frequently above the height of the collar, so it was pouring into the boat. In fact, in these conditions, water is almost always above the collar, and it's eye-opening how much water can flow down the pipe. The weather strip on the locker door looks fine, but two design points effectively allow free flow of water from the cockpit to the locker and then into the lazarette below: 1) a one-inch unobstructed drain hole in the bottom of the locker that allows water to flow out but, in rough water, it also allows water to flow in, and quickly; 2) the door has an open grill for ventilation. I love locker ventilation but I'm even a bigger believer in keeping water out of the boat.

1) Install a one-way valve in the cockpit locker drain to allow water out, but prevent unrestricted flow in.

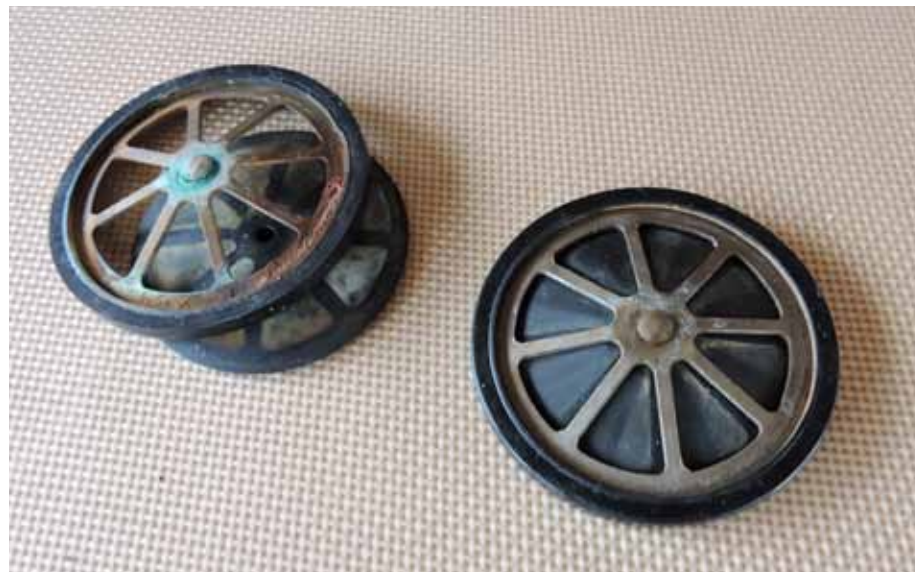
On this pump, it's faster to change the valves than change the pump, so I removed the four bolts that expose the bellows and valves. With the pump apart, I could see that the outlet check

valve had corroded and that the rivet holding the valve in place had failed. Likely this happened about five minutes prior to the high-water alarm going off, since it was previously cycling frequently but keeping up with the inflow.

Prior to this incident, I felt the Jabsco model #34600-0010 was a good primary bilge pump, but have since have concluded it has sufficient quality and volume problems that it should not be counted on for more than routine bilge dewatering. Besides rivets that corrode, another weakness is that the bakelite pump base can crack if over-tightened or if tightened unevenly. The second is easy to avoid but the first can fail at any time. Testing the pump is good practice, but even after diligent testing, there is still no assurance it'll be there when you need it: It could fail five minutes after the last successful test. To be on the safe side, the valves need to be replaced at least every year or two.

Opposite: The rivets holding the valves in place on the Jabsco model #34600-0010 pump can corrode and fail at any time. The pump should not be counted on for more than routine bilge dewatering. **Above:** This was the first ocean crossing where we've felt serious doubts—even a touch of fear—and actually considered turning back.

3) Install a second automatic bilge pump just above the primary bilge pump to fully back it up and ensure that pump faults don't allow high bilge water. We could move down the Rule 3700 that is mounted about three feet above the bilge bottom but, instead, we'll leave that pump in place and install a Rule 4000 just above the primary pump.

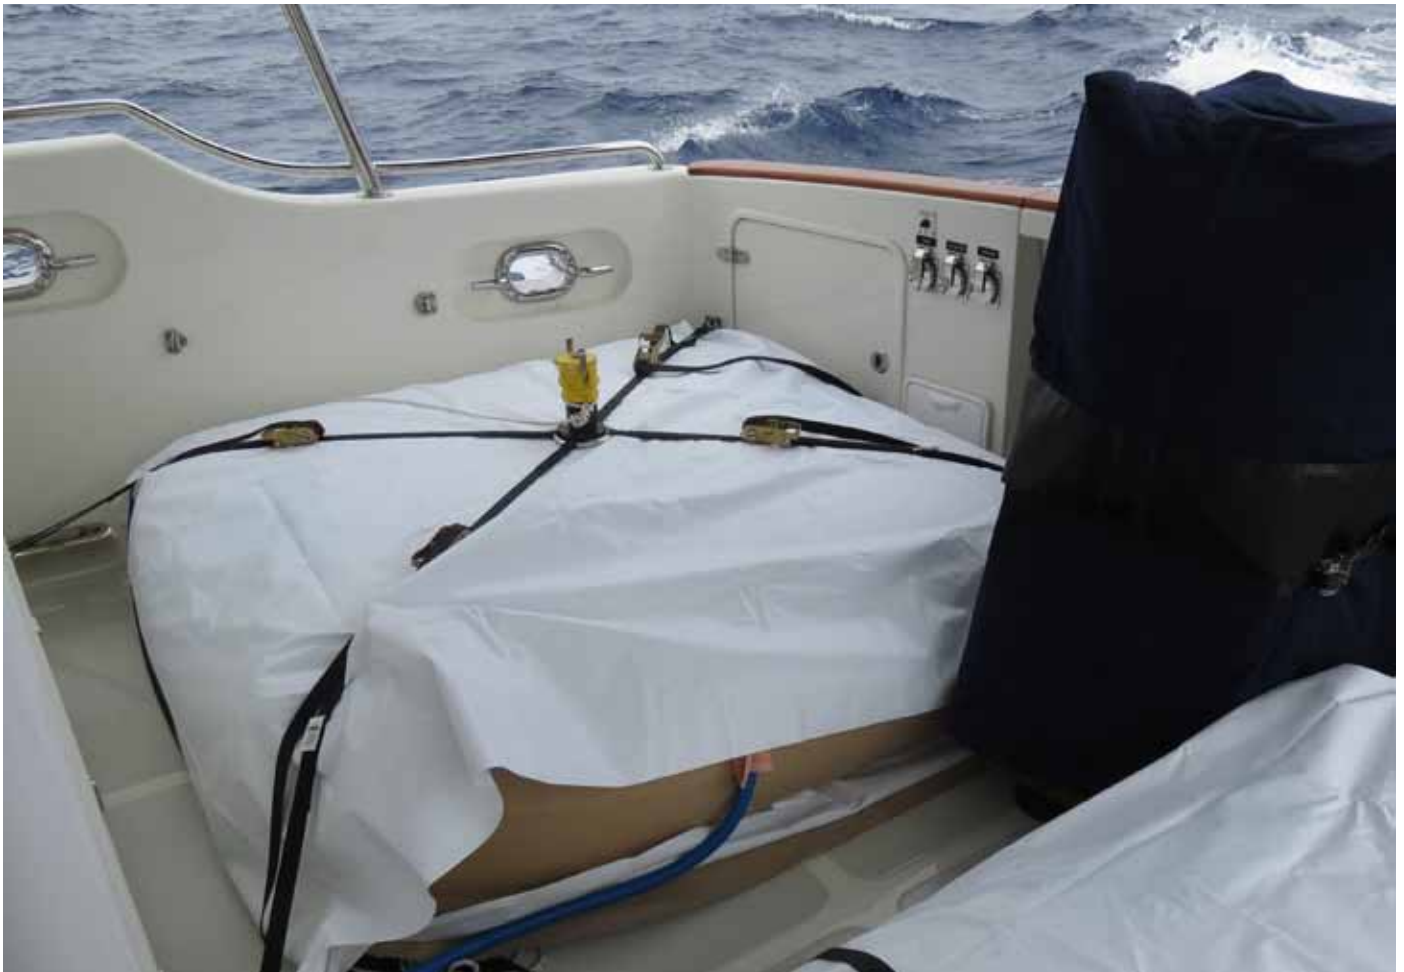
In thinking through why this water ingress problem was so bad, part of the problem is the fuel bladder has a slight diagonal twist to it on the cockpit floor. The two corners close off a small area in the corner of the starboard cockpit locker. This dams a small amount of water in the after corner of the boat. A deck drain and a scupper there normally allows water to run out from that area but, whenever we get hit with big waves, water geysers up from that deck drain and runs the water level up at the locker door. When waves roll over the transom, almost the entire volume falls into this area with only a single scupper and deck drain. It's not much water but it's a small area so there is 12 to 18 inches of water just about constantly in such conditions. I suspect with bladders or without, these conditions would definitely be bringing water into boat, but the bladder placement exacerbated it.

Above: The fuel bladder placement likely exacerbated the water ingress through the cockpit locker. **Left:** We expected winds in the 20-knot range, but instead were seeing steady 30-35 knots with gusts to 47.
