High Seas, High Water

In Gale Conditions off the Treacherous

Grand Banks, Dirona Takes on Water

JAMES & JENNIFER HAMILTON

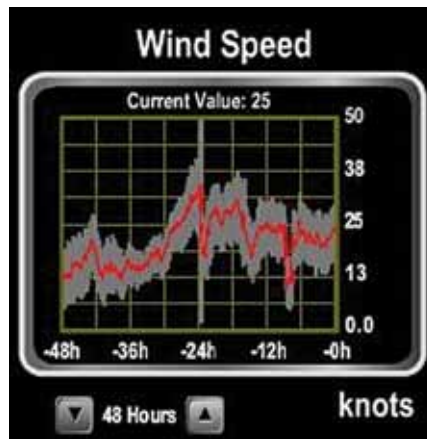
Above: The fuel bladder placement likely exacerbated the water ingress through the cockpit locker. **Left:** We expected winds in the 20-knot range, but instead were seeing steady 30-35 knots with gusts to 47.

1) Install a one-way valve in the cockpit locker drain to allow water out, but prevent unrestricted flow in.
